Manhole Inspection Summary

Manhole # S55K__053MH

Insp Date: **5/29/08 11:47 AM**

Location Address: **3601 fait ave**

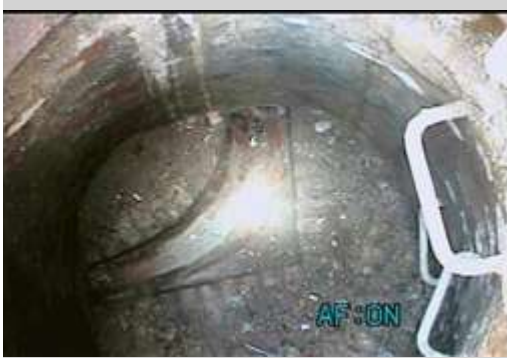
Miscellaneous

Steps Count: **3** Missing: **0** ☐ Corroded

steps

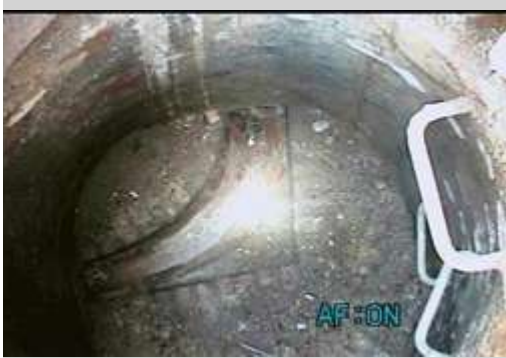
Defect 2

Condition: ☐ Sound ☐ Cracked ☐ Root Intrusion ☐ Deteriorated ☐ Leaks ☒ **Debris**

debris

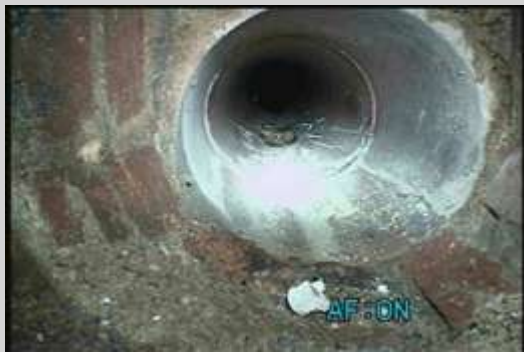
12 O'Clock Outflow

8 in. Circular Gravity Sewer
Pipe Out @ 12 O'Clock

Deposits: ☒ None ☐ Mud ☐ Sludge ☐ **Debris** ☐ Grease

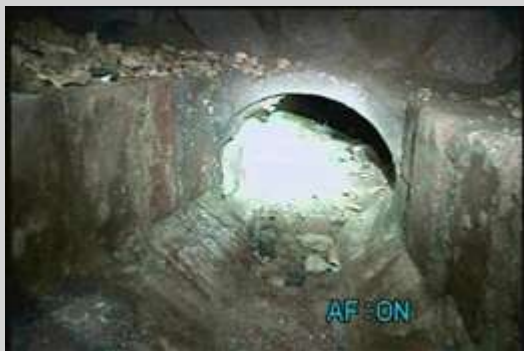
9 O'Clock Inflow

8 in. Circular Gravity Sewer
Pipe In @ 9 O'Clock

Deposits: ☐ None ☐ Mud ☐ Sludge ☒ **Debris** ☐ Grease

Silt Depth: 3 (in.) Deposits Extent: **Medium**
